NASA  
Technical Memorandum 4195

# Evaluation of Composite Components on the Bell 206L and Sikorsky S-76 Helicopters

Donald J. Baker

AUGUST 1990

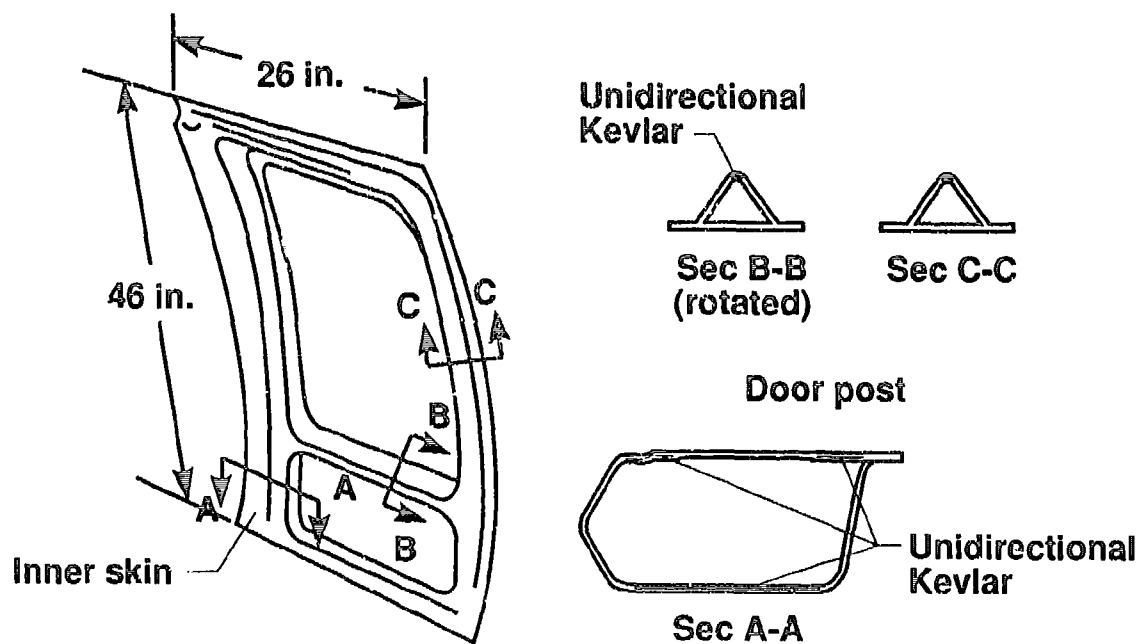
The litter door has had very few problems with the composite material skins. However, a major problem occurred with the metal hinges that are used to hold the cabin door. The hinges were under-designed and failed in service when someone pushed the cabin door open too far. New high-strength hinges have been installed and the litter doors are back in service.

Buckling occurred in the outer skin of the litter door on four helicopters parked in the Southwest United States desert during the summer. The probable cause of buckling is the thermal mismatch between the Kevlar-49/epoxy skins and the plexiglass window. This window was bonded to the exterior skin. The coefficient of thermal expansion of the plexiglass window is  $4.5 \times 10^{-6}$  in/in/°F, and the coefficient of thermal expansion for the Kevlar/epoxy

skin is near zero. Personnel at this desert facility have taken surface-temperature measurements on aluminum helicopter structures with the same external paint scheme as the composite skins, and their results show that the temperatures typically reach 200°F to 225°F during the summer. The bond between the door structure and window was broken near the buckle on the four doors. The doors were modified and a rubber seal was bonded between the door structure and window to permit relative thermal expansion. Other normal service problems have occurred such as broken windows, bumps, and scratches, all of which were repaired at the operator's repair facilities according to repair instructions received with the kits.

Figure 2. Bell 206L Kevlar/epoxy litter door.

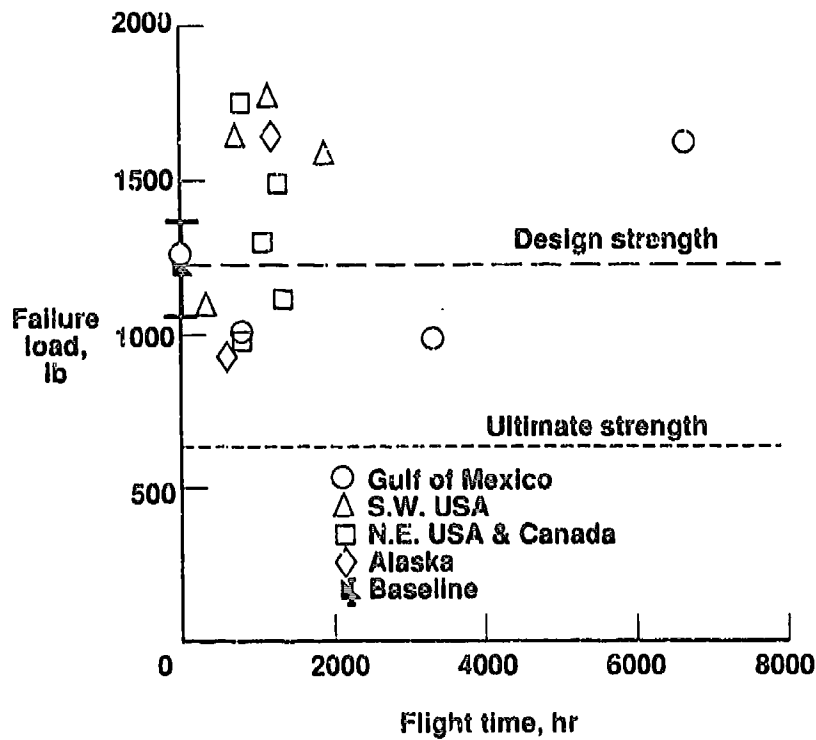
Failure loads (table 1) for 15 litter doors vary from 901 to 1768 lb. These failure loads are the total loads on the door including the hinge reaction from the cabin door. Failure loads as a function of flight hours are shown in figure 9. Each open symbol represents the failure load for a different exposure area. Also shown in figure 9 are two strength requirements, ultimate strength and design strength. The ultimate strength is the usual strength that an aircraft component must meet or exceed at all times. The design strength shown is the strength that an unconditioned component (as-fabricated) must meet or exceed. The design strength is intentionally greater than the ultimate strength and is the product of the ultimate strength and the environmental factor determined from the environmentally conditioned material coupon specimens (ref. 2). This strength is shown for reference only since the components tested are between as-fabricated and fully conditioned. The solid symbol represents the average baseline failure load (reported in ref. 2), which is the average of five components selected at random from the production lot of 45 components. The range of failure loads for the baseline tests is also shown in the figure. All litter doors had failure loads that exceeded the ultimate strength requirement of 635 lb (ref. 2), and nine of the doors had failure loads that exceeded the design strength of 1229 lb. It is acceptable for the failure load of doors that have been environmentally exposed to be below the design strength as long as the load is higher than the ultimate strength. Failure loads do not appear to be a function of exposure time. Initially in the postservice testing (ref. 3),

Figure 9. Failure load of litter doors after exposure.

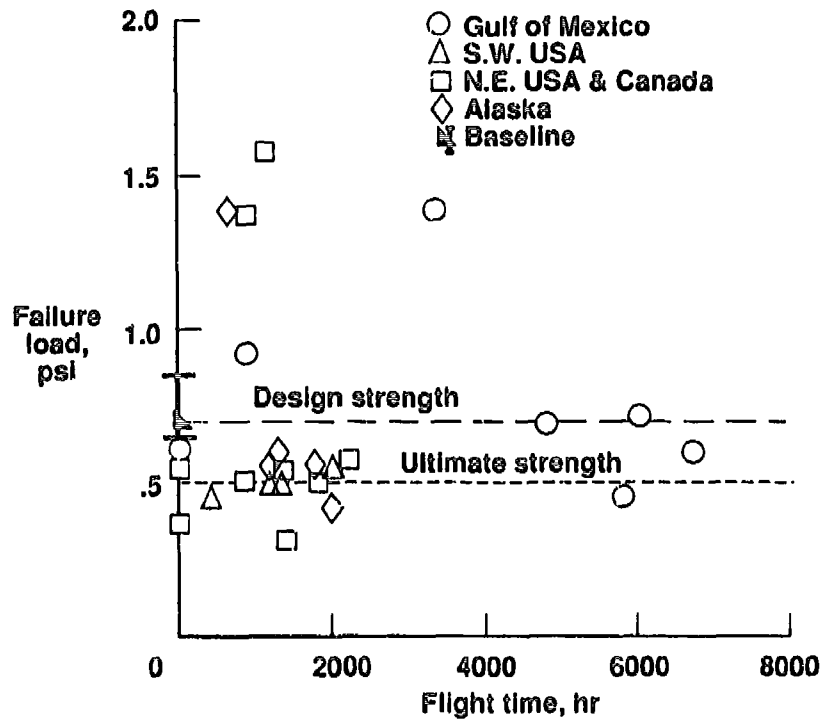
Failure loads (table 2) for 26 baggage doors vary from 0.32 to 1.57 psi, and service times for the doors vary from 386 to 6750 hours. Failure loads as a function of flight hours are shown in figure 11. Each open symbol represents the failure load for a different exposure area. The solid symbol represents the average baseline strength. These baggage doors are the components that developed large disbonds and have been removed from service. Most of the test points represent baggage doors that have some disbond between the core and the outer skin. Twenty-one of the doors had failure loads that were below the design strength of 0.70 psi, and nine doors had failure loads that were below the ultimate strength requirement of 0.50 psi (ref. 2). The stiffness of the baggage door as a function of the flight hours is shown in figure 12. The stiffness was determined by measuring the deflection at the center of the door as the loads were applied. The disbonds do not appear to affect the stiffness as much as the strength. The baggage doors that have been tested have accumulated a total of 51 798 hr of flight service.

Figure 11. Failure load of baggage doors after exposure.

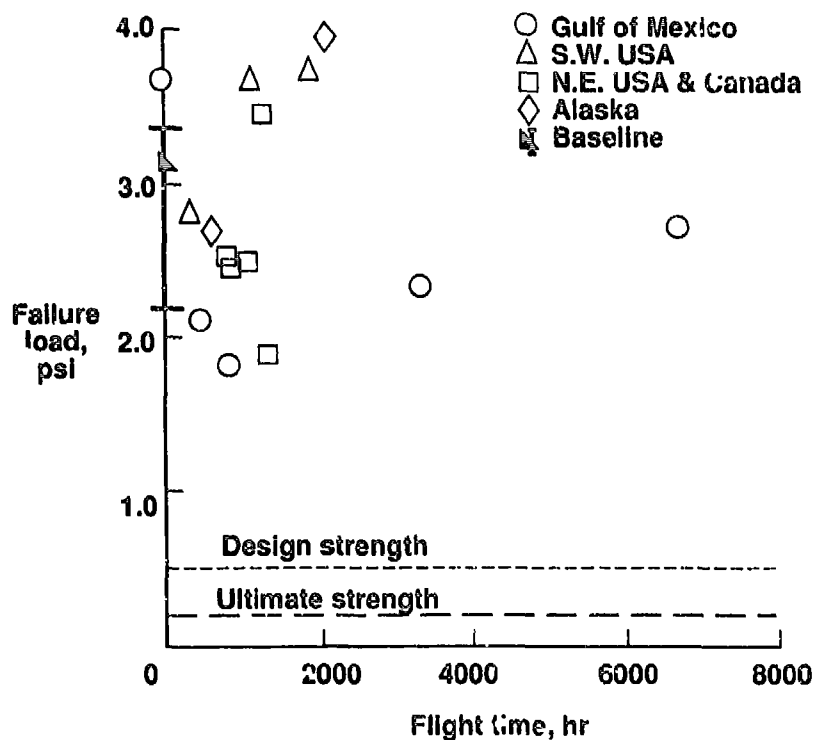
Failure loads (table 3) for 15 forward fairings vary from 1.80 to 3.93 psi, and service times for these components vary from 386 to 6750 hr. Failure loads as a function of flight hours are shown in figure 13. Each open symbol represents the failure load for

a different exposure area. Failure loads vary from 1.80 to 3.93 psi and exceed the design strength of 0.49 psi (ref. 2) by more than a factor of 3. Failure loads for forward fairings tested to determine the baseline strength (ref. 2) varied from 2.2 to 3.4 psi. Failure loads for 8 of the 15 forward fairings tested are between 2.2 and 3.4 psi. The large scatter in the failure load could be the result of variations in the fabrication process. Considerable variation could result from putting down the single ply of Kevlar fabric (style 281) on a compound contoured surface. The lay-up requires cutting and overlapping the fabric at many places to prevent wrinkling on the surface. The stiffness of the forward fairing as a function of the flight hours is shown in figure 14. The stiffness was calculated using measurements for the deflection of the upper surface at a point 14.5 in. from the aft end as the load was applied. The stiffness of all fairings, except one, exceeded the stiffness of the certification fairings. The fairings that have been tested accumulated a total of 23 730 hr of flight time.

Figure 13. Failure load of forward fairings after exposure.

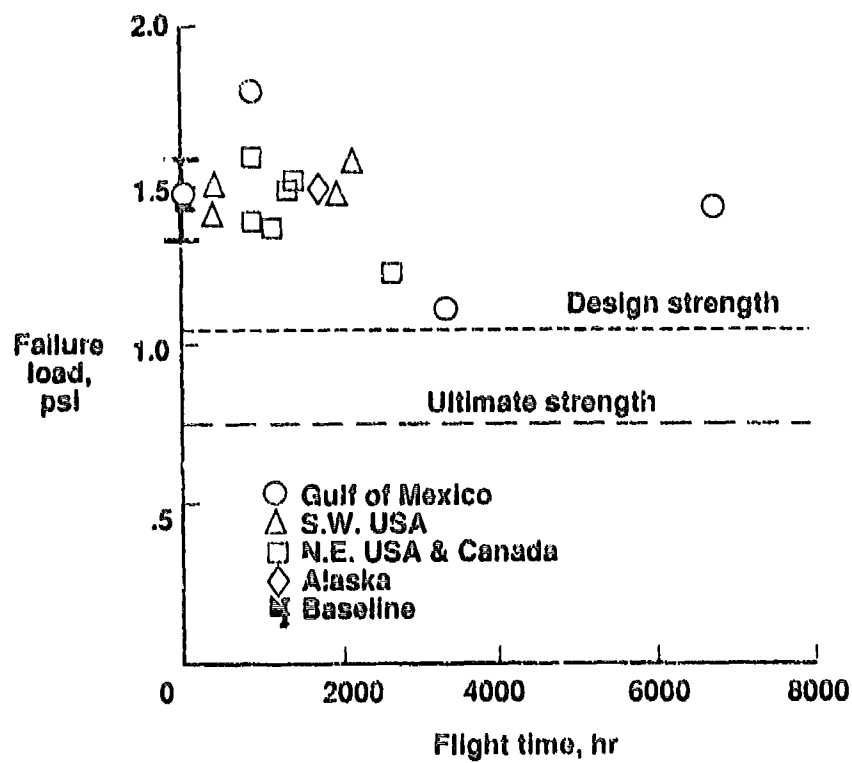
Failure loads (table 4) for 15 vertical fins vary from 1.12 to 1.80 psi, and service times for these fins vary from 385 to 6750 hr. Failure loads as a function of flight hours are shown in figure 15. All fins exceed the design strength of 1.05 psi. Failure loads for 12 of the 15 fins are between 1.35 and 1.57 psi, which is the range of failure loads for the baseline tests (ref. 2). One fin that was struck by lightning is identified in table 4. The fin was damaged at the top with no damage in the structural box. This fin failed at 1.23 psi with no apparent effect from the lightning strike. The environment does not appear to affect the failure load of the vertical fins. The stiffness of the vertical fin as a function of flight time is shown in figure 16. Stiffness was calculated using measurements for the tip deflection as the simulated aerodynamic load was applied. The certification deflection data for the fin are not available. The vertical fins that have been tested have accumulated 26 139 flight hours.

Figure 15. Failure load of vertical fins after exposure.

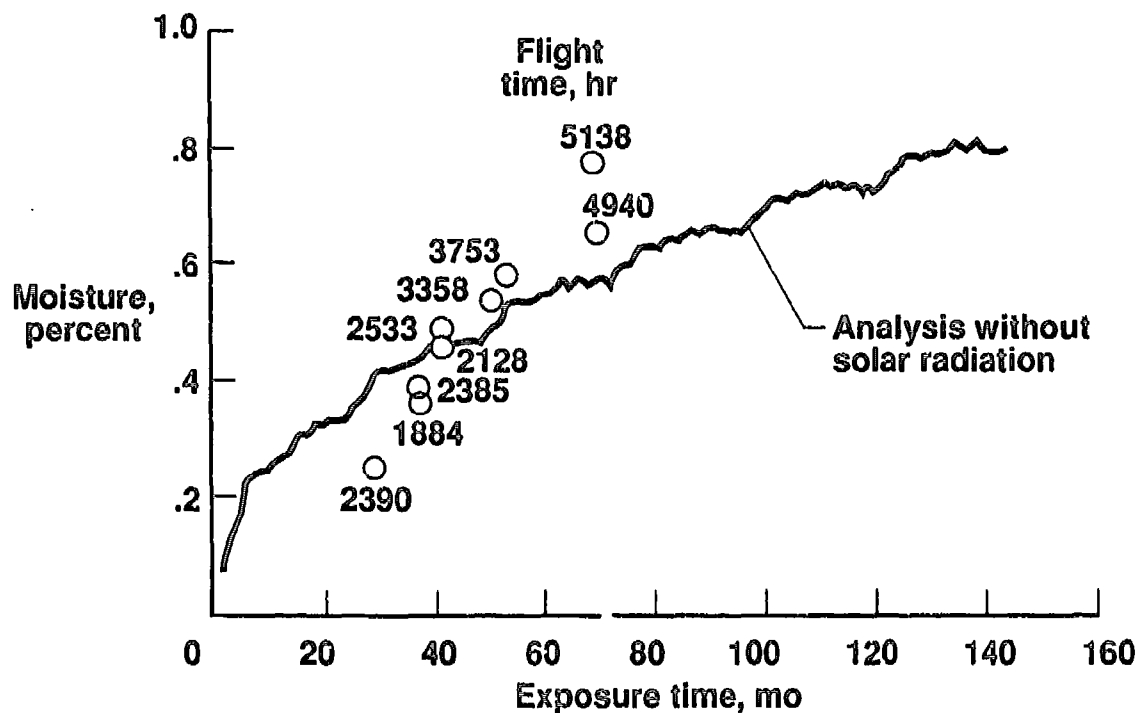
A predicted moisture-time profile (ref. 6) for the tail rotor spars (ref. 5) operating in the Louisiana Gulf Coast region is shown in figure 31. Weather data from Lake Charles, Louisiana, were used in predicting the absorbed moisture. Measured moisture values (table 7) are shown in figure 31 on a plot of percent moisture as a function of exposure time. As can be seen in figure 31, the measured moisture values are below the predicted moisture values for the low exposure time (30-40 months), whereas the measured moisture values are for an exposure time of 70 months higher than the predicted values.

Figure 31. Measured and predicted moisture content for S-76 tail rotor spars exposed at Lake Charles, Louisiana.
